U.S. EPA REGION VIII
TECHNICAL ENFORCEMENT PROGRAM
RCRA CORRECTIVE ACTION ASSESSMENT REPORT

Facility: ASARCO East Helena Plant
100 Smelter Road
East Helena, MT

Inspection Type: Corrective Action Assessment Inspection

Date: May 8, 2007

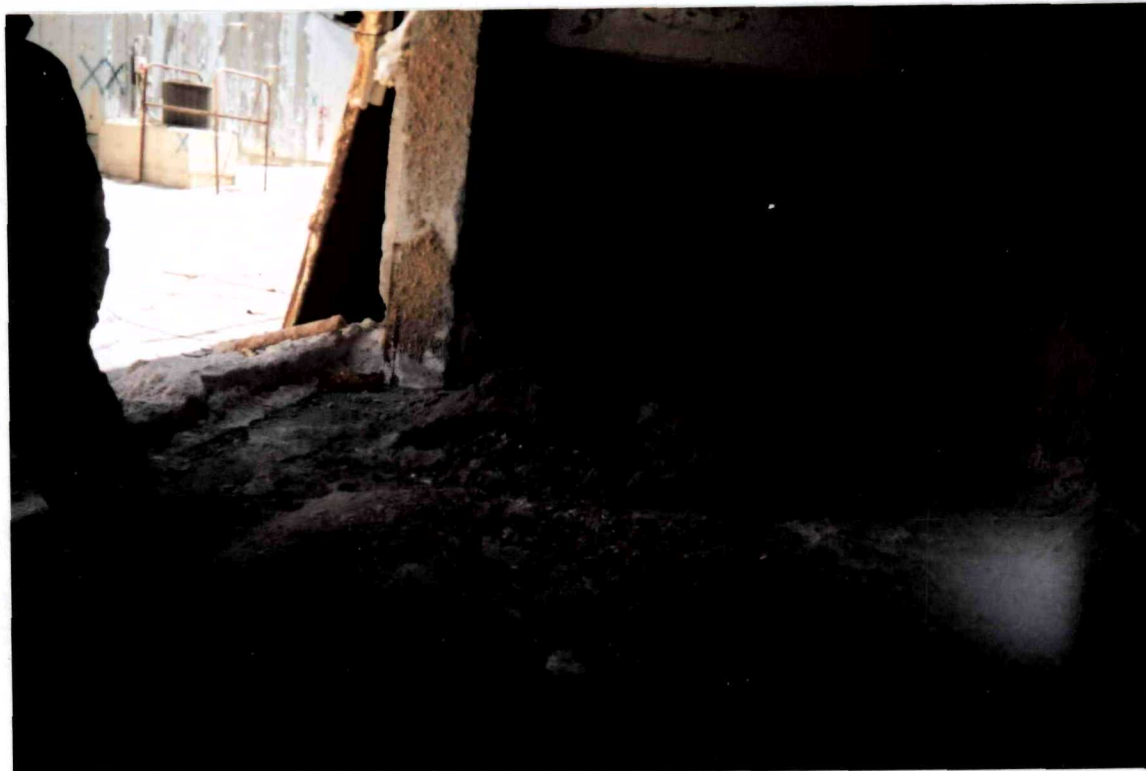
ASARCO had opened portions of the baghouse and Monier flue for Ms. Jacobson's inspection. Mr. Cox used a metal bar as a sounding rod to help determine the portions of the flue which had a floor. As noted in the attached photographs, although the flue had been previously cleaned, flue dust coated the walls and floors and small mounds were periodically encountered along the floor.

Photo 2; Facility: ASARCO East Helena Smelter; Subject: Piles of Flue Dust on Floor of Flue; Photographer: Linda Jacobson; Date: May 8, 2007

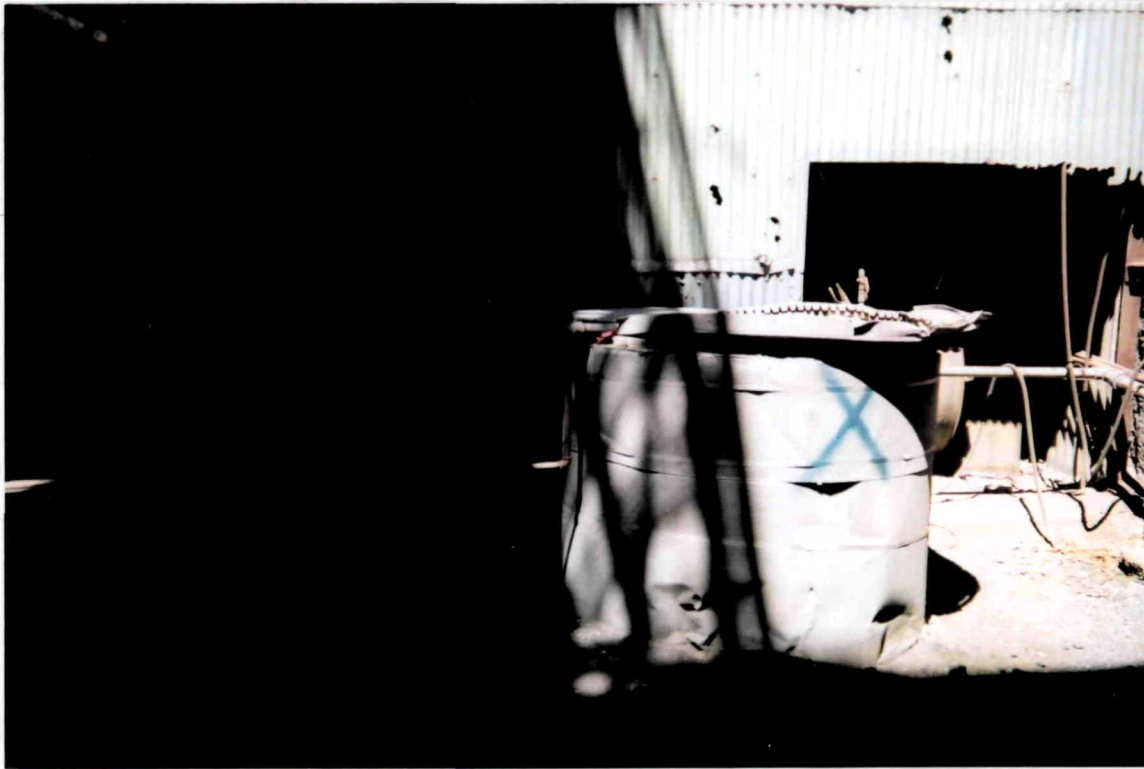
Mr. Cox clarified that Demolition Stage 1, Phase IV, will include removal of those structures necessary for installation of the slurry wall at the former Speiss/Dross Plant area first. He explained that the "excess soils" on the demolition diagrams refers to 2 areas: 1) the Highline Trestle, and 2) the feed hopper to the crushing mill. These are above grade elevations. The 4 foot well to be abandoned was used to keep groundwater low in the old ore storage building. The New Deal building would flood. The Direct Smelt Building is located there now. The proposal is to flow fill this "well" which contains underground utilities, including 6-inch water lines.

Photo 3; Facility: ASARCO East Helena Smelter; Subject: 4 Foot Well Targeted for Closure;
Photographer: Linda Jacobson; Date: May 8, 2006

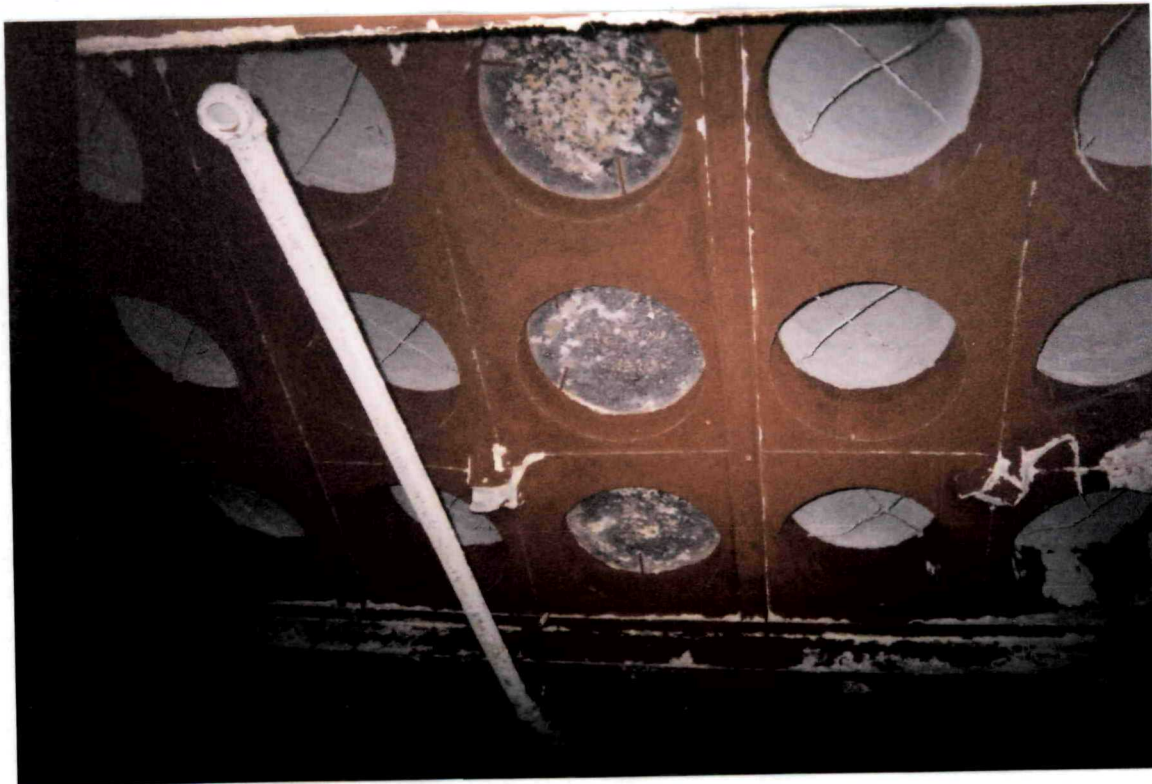
Photo 4; Facility: ASARCO East Helena Smelter; Subject: Inside Baghouse Cellar;
Photographer: Linda Jacobson; Date: May 8, 2007

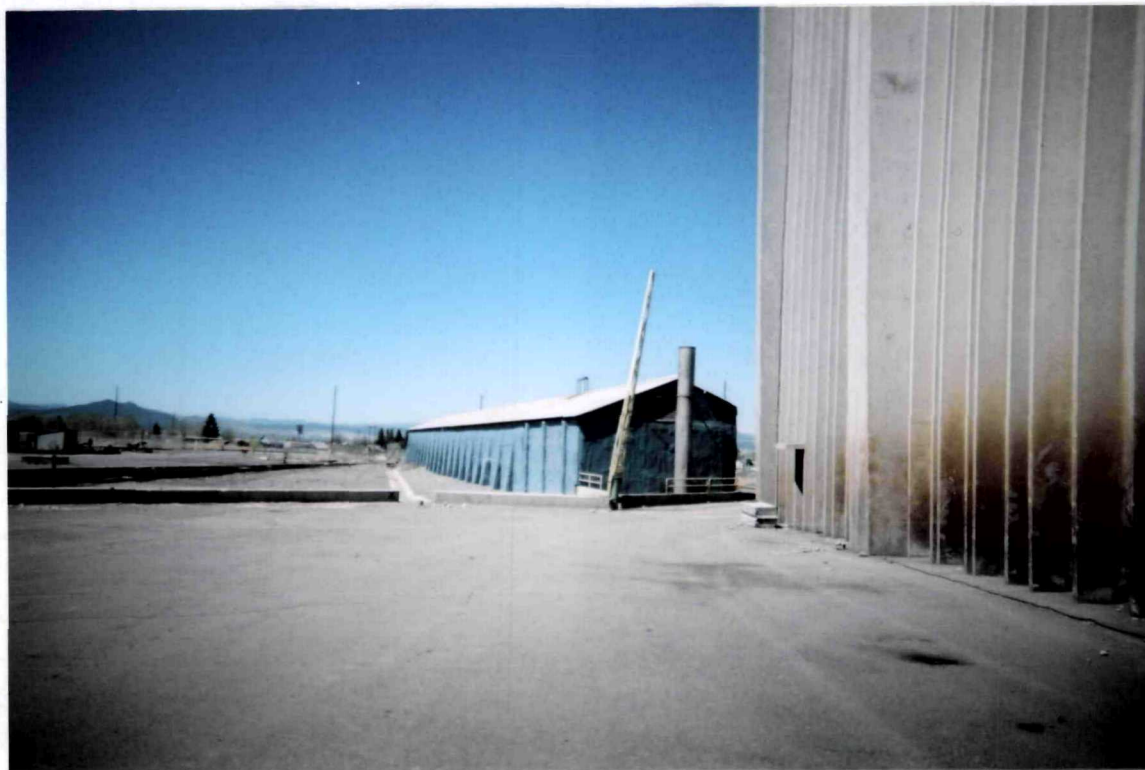
During its operation, the thaw house was heated by direct fire. It still contains 6 gondolas, 1 flat car, and one 45-ton GE locomotive. The structure overlies a dirt floor with rails. Ms. Jacobson was shown the lower floor of the Sampling Mill, which also has a dirt floor. During its operation, a 100-lb sample was shipped in on rails then conveyed upstairs via the elevator where a one-pound representative sample was made.

Photo 5; Facility: ASARCO East Helena Smelter; Subject: Thaw House Scheduled for 2007 Demolition; Photographer: Linda Jacobson; Date: May 8, 2007

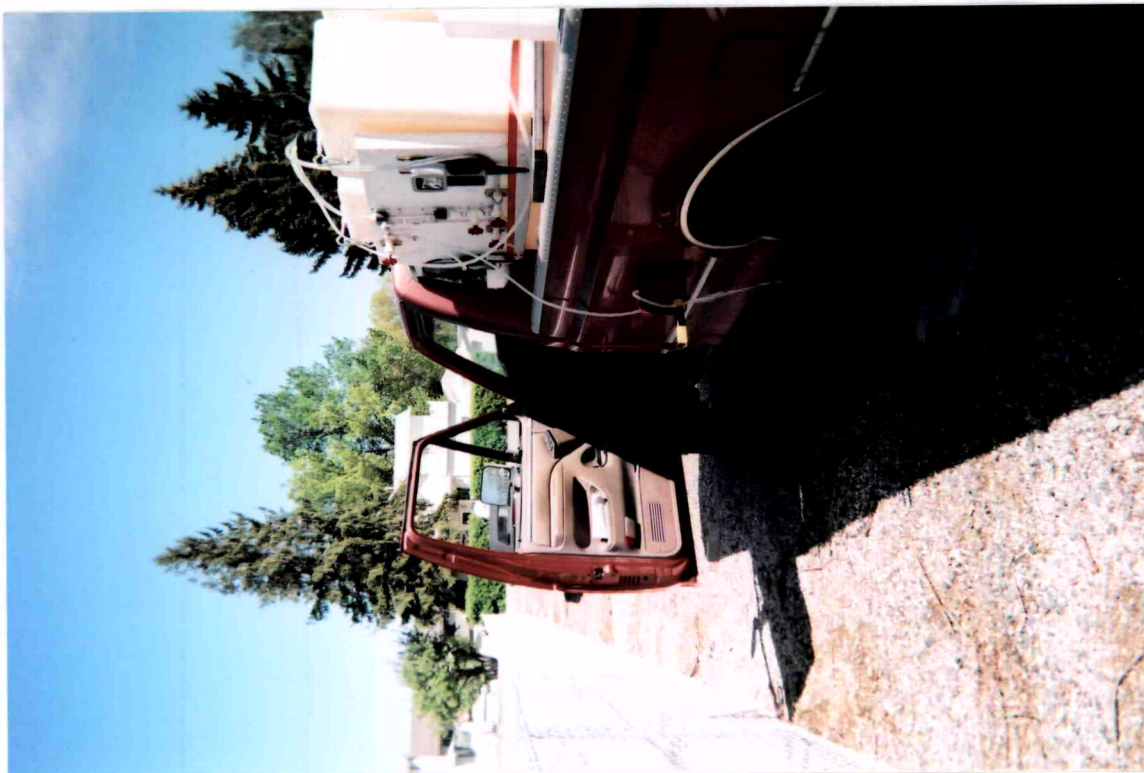
Photo 8; Facility: ASARCO East Helena Smelter; Subject: Decon Water Being Discharged on Ground; Photographer: Linda Jacobson; Date: May 11, 2007

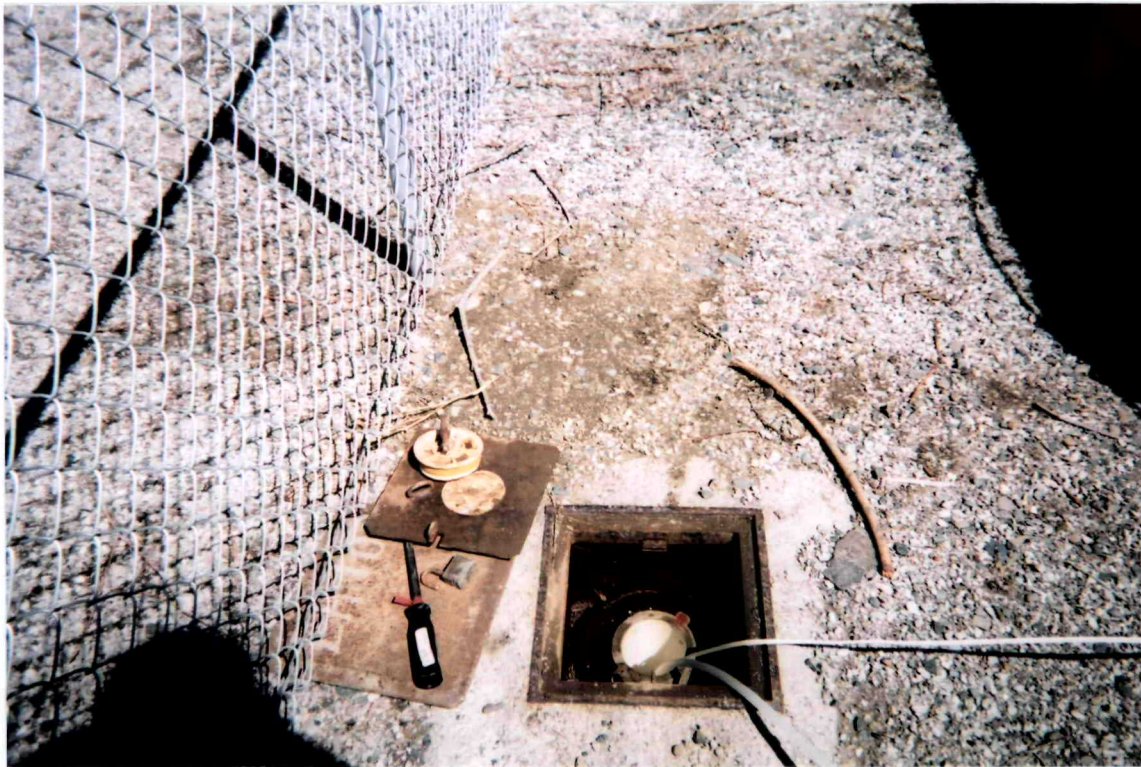
Well EH-102 is a flush mounted well with a screw cap and internal locking lid. The total depth measured was 35 feet, with a static water level of 9 feet. Ms. Jacobson observed the collection of the sample for common ions, followed by collection of the other well samples after the field filter was attached. Three casing volumes were purged from the well. It was noted that the sample container was rinsed three times with sample water before collection. Samples were stored in a cooler, following collection. Upon completion of sampling, the well was relocked and the outside lid replaced.

Photo 9; Facility: ASARCO East Helena Smelter; Subject: Well 102 Opened for Sampling; Photographer: Linda Jacobson; Date: May 11, 2007

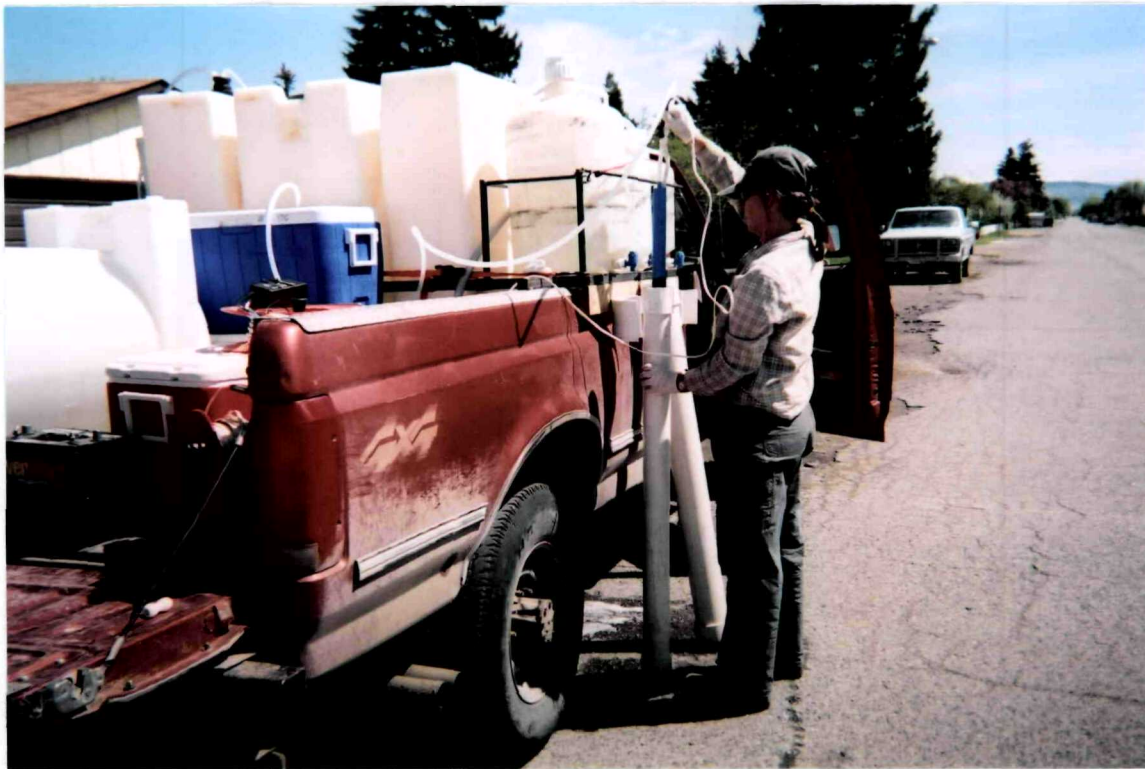
The sampling team then proceeded to the next well, EH-115, located on Riggs Street. Ms. Jacobson was able to watch the collection of an equipment rinse sample following deconning of the pump. The pump is deconned using a total of four gallons of a soapy water rinse, followed by tap water, then DI water. After decon, DI water was run through the pump and a sample for metals was collected.

Photo 13; Facility: ASARCO East Helena Smelter; Subject: Deconing Pump: Soap, Tap, DI Water; Photographer: Linda Jacobson; Date: May 11, 2007

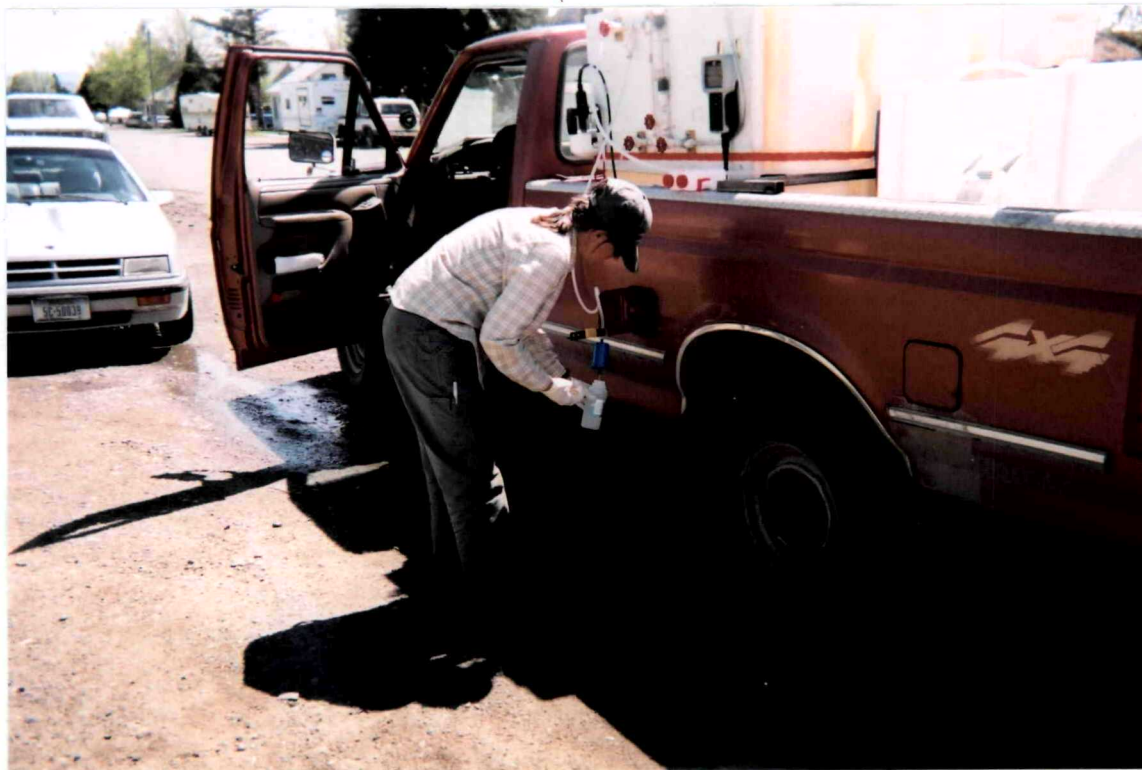
Photo 15; Facility: ASARCO East Helena Smelter; Subject: Equipment Rinsate Sample Collection; Photographer: Linda Jacobson; Date: May 11, 2007

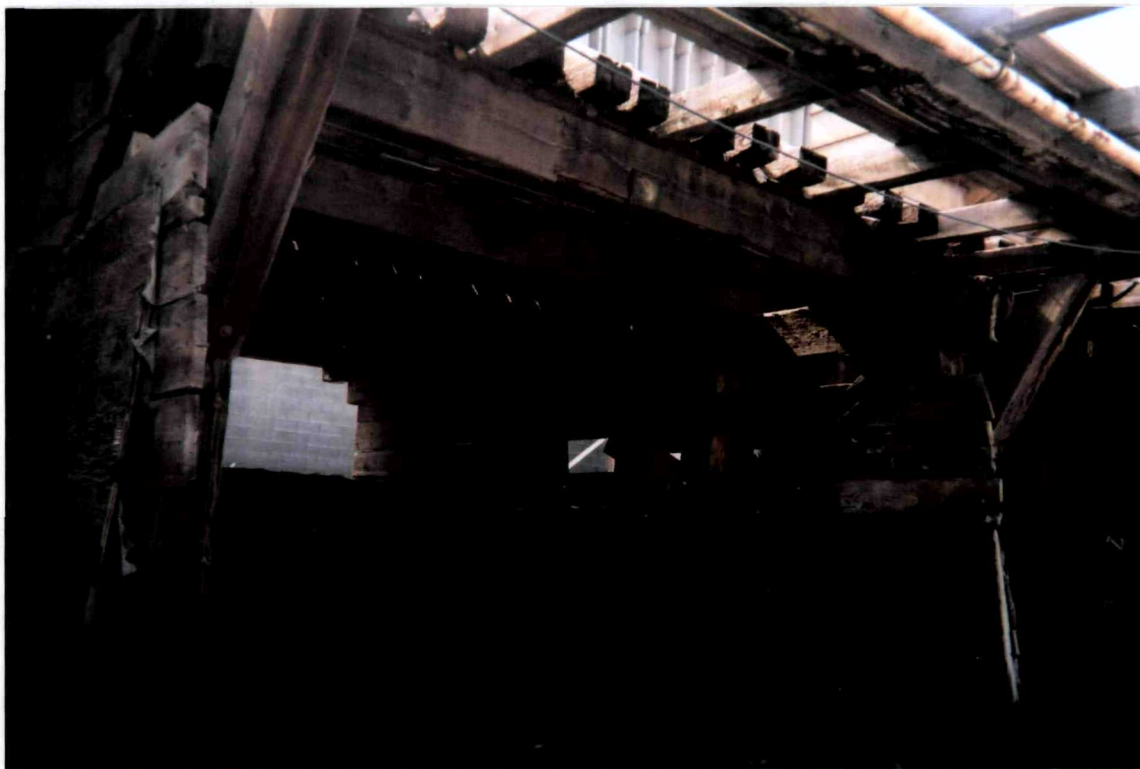
There are five sand filters, which had been used to filter out Upper Lake water for use in the cooling tower. The sand screens in the bottom corroded out. Any sand in them, likely a minimal amount will be disposed in the CAMU also. Based on age, Mr. Cox believes the Highline Trestle timbers were treated with creosote.

Photo 23; Facility: ASARCO East Helena Smelter; Subject: Highline Trestle; Photographer: Linda Jacobson; Date: May 11, 2007

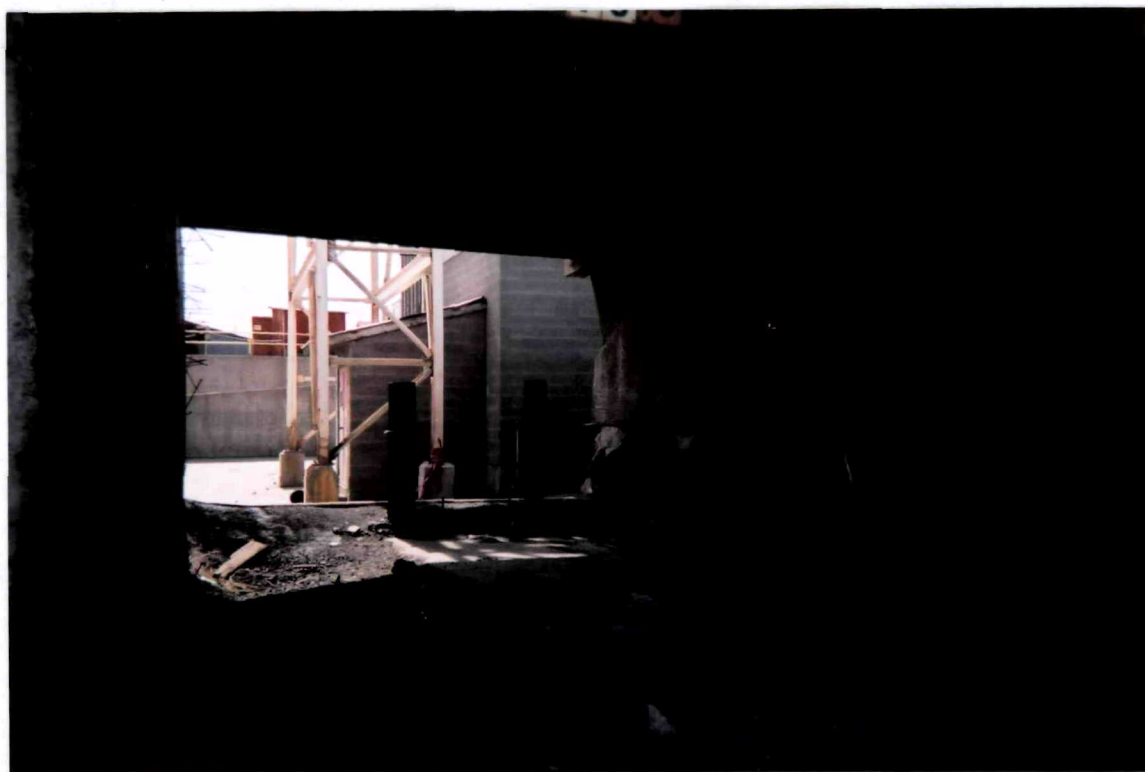
Photo 24; Facility: ASARCO East Helena Smelter; Subject: Highline Trestle Storage Bin; Note: Partial Dirt Floor; Photographer: Linda Jacobson; Date: May 11, 2007
